City of Carthage  
Blight Declaration Request

Project Name: Burlingame Chaffee Redevelopment

Common address of property: 136 East 4<sup>th</sup> Street, Carthage, MO 64836

## **Section 1: Introduction**

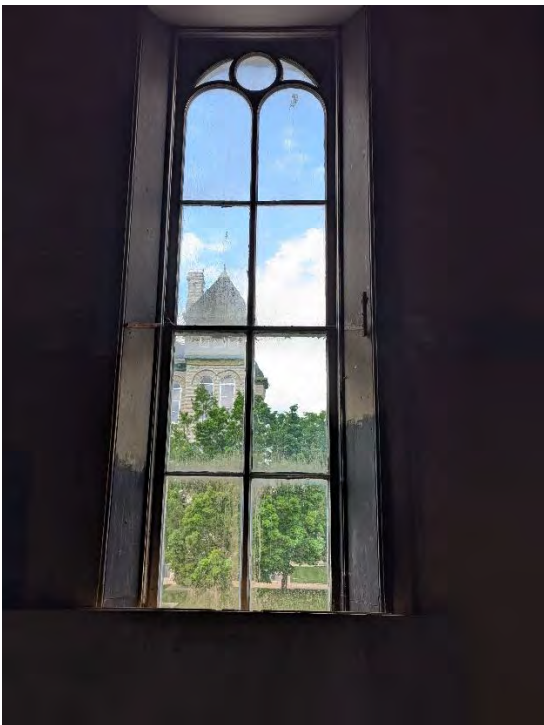
The building has historic windows, which are aesthetically nice to look at, but don't meet modern expectations regarding insulation factors of modern development/redevelopment projects.

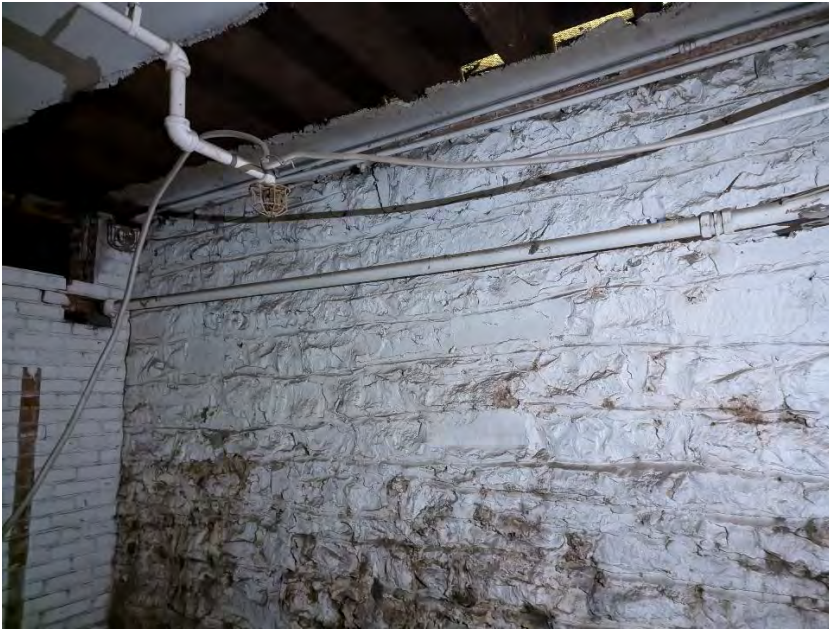
The pictures above show gaps to the outside that are visible from inside the basement. After decades of routine maintenance being ignored, buildings will settle and mortar will crack leading to these infiltration opportunities for both environmental and insects to enter the property, helping expedite deterioration.

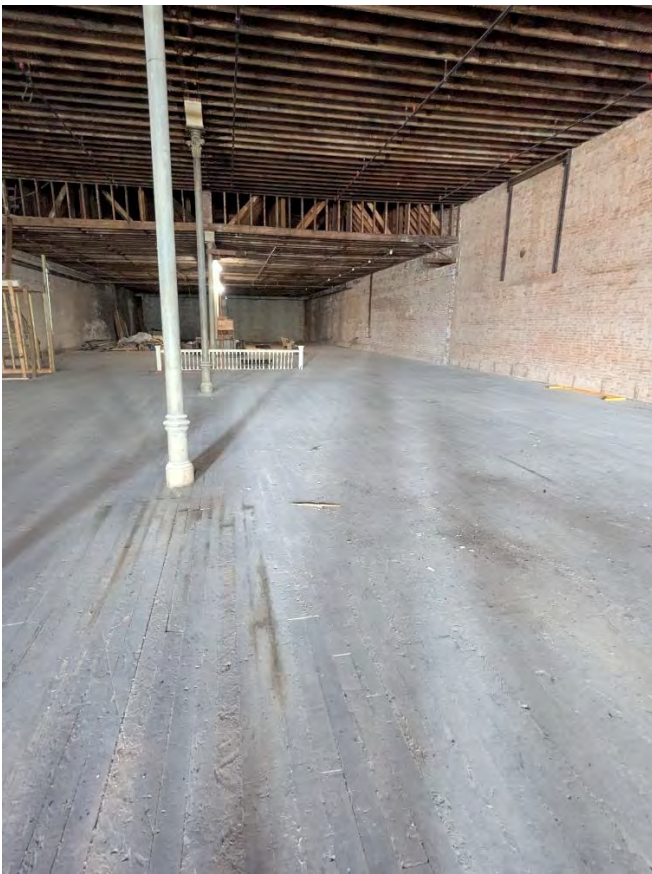
This picture is looking from the front towards the back of the structure on the top floor of the building.

It's believed that all this flooring will need to be removed after its original installation decades prior. Age has not been kind to its condition, and other materials used in construction and renovation.

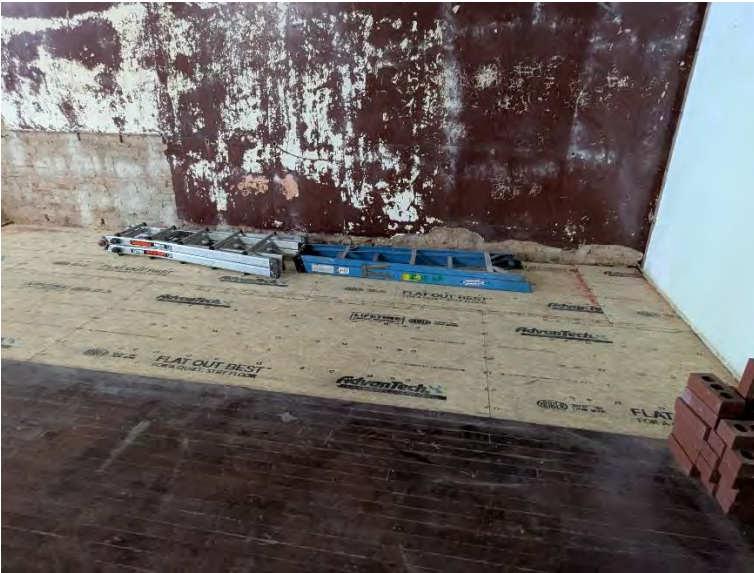
This picture shows where flooring had to be repaired as a result of age-induced deterioration.

There are additional areas that needed to be fixed to make sure the building was safe to walk inside.

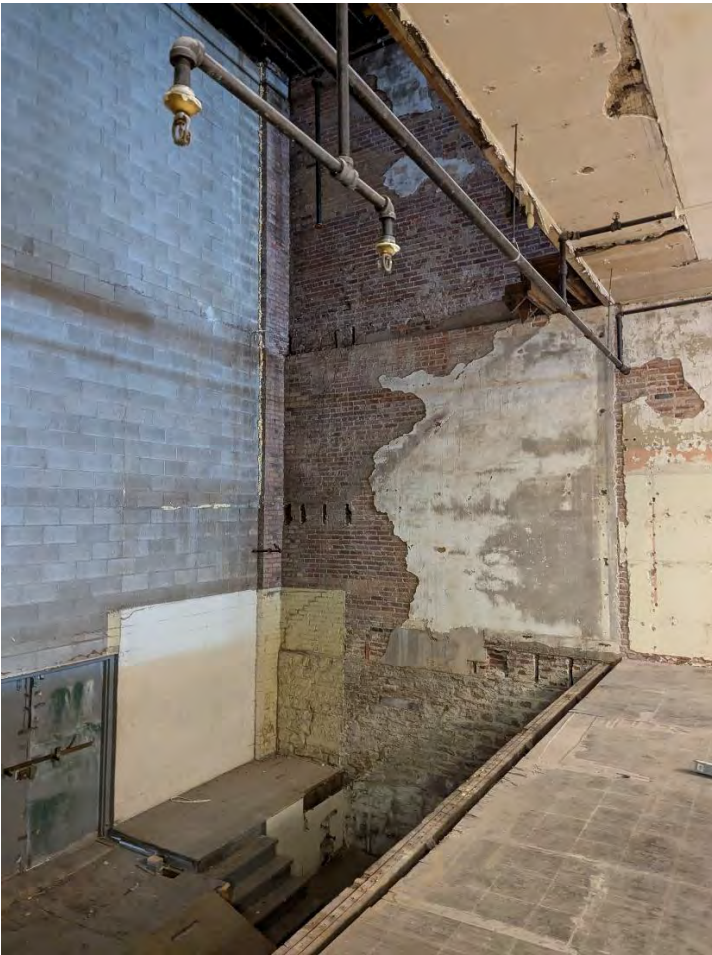
These pictures show where there had formerly been a staircase between the floors.

It was determined that this staircase was not structurally sound due to its age and outdated design. The staircase was not connected to the building, but was effectively free standing in the space.

To ensure compliance with Americans with Disabilities Act (ADA) standards and for overall customer experience, an elevator will be installed connecting the public access floors.

A new staircase will also be constructed.

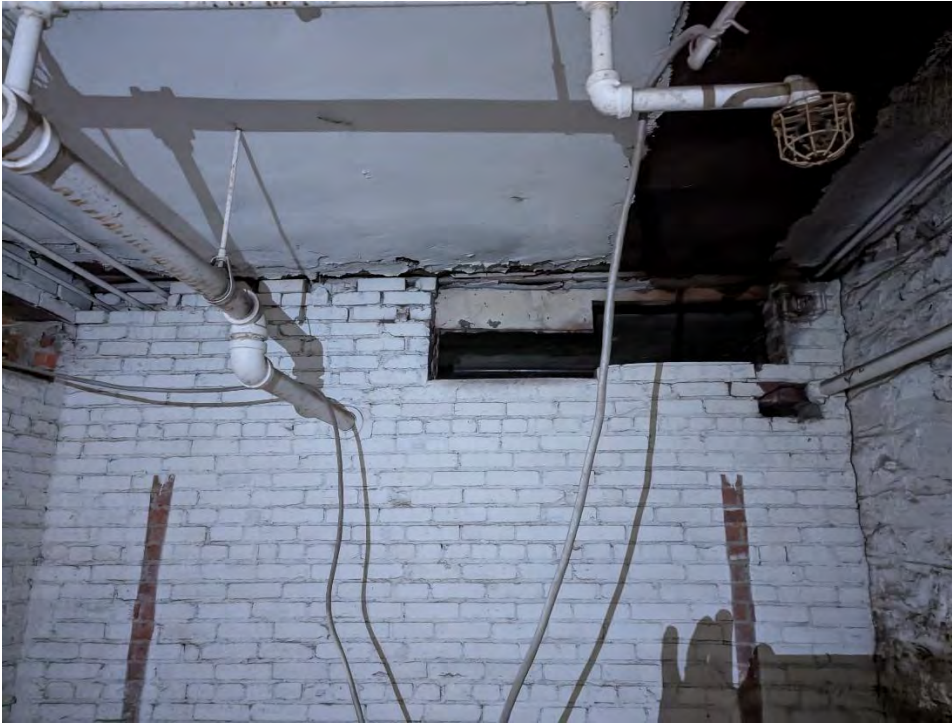
Pictured here are two walls that will need masonry repair as part of the redevelopment process. The white room is an interior wall with several holes in both the wall and ceiling.

The unpainted brick wall shows an area where the bricks have fallen out of their original homes as wall and are simply placed in the remaining hole.

It's possible there are additional needed repairs that will be found when these holes are investigated.

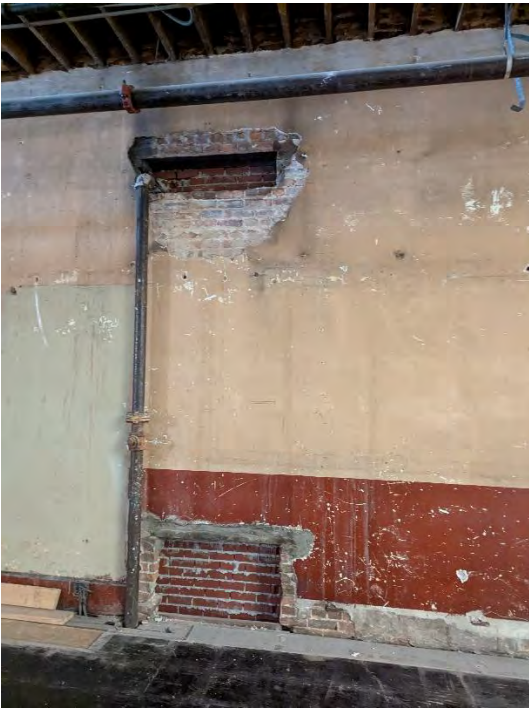
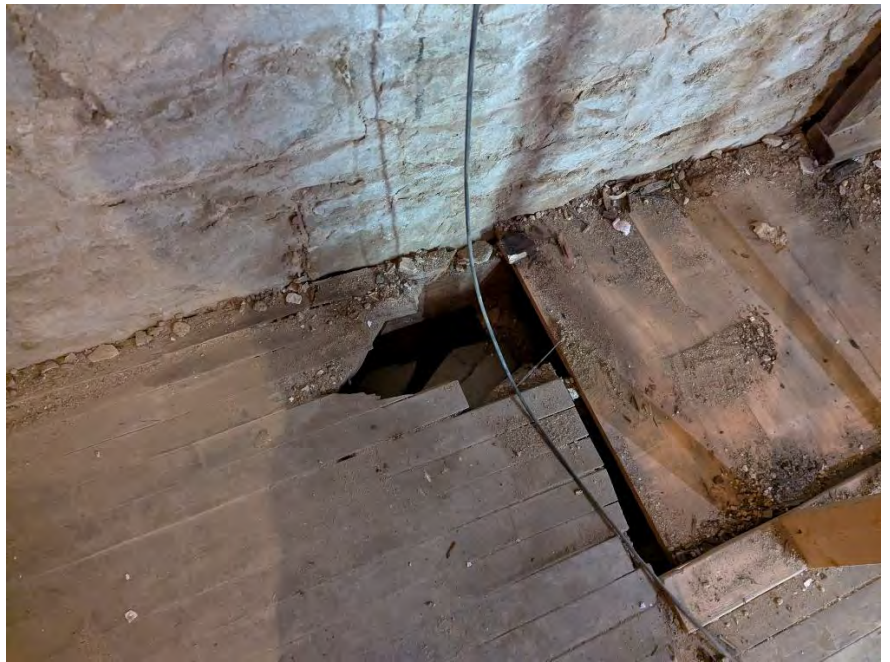
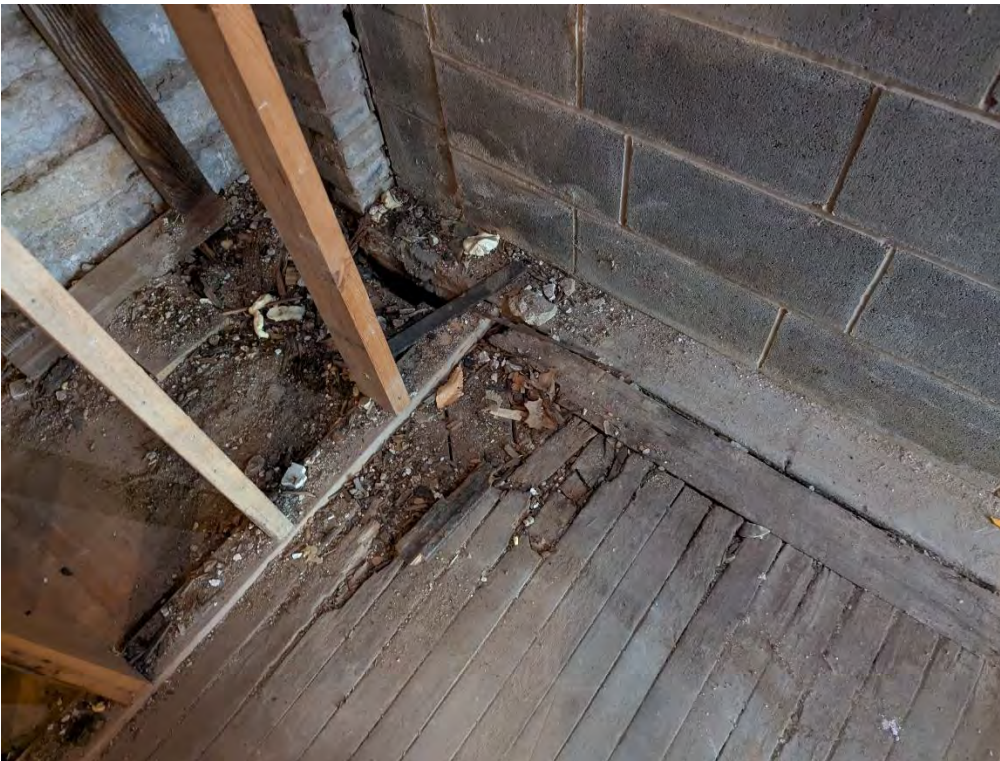
Additional areas showing deterioration are shown on this page.

These areas include a hole in the floor, deteriorated floor, which will lead to additional holes and gaps in the concrete wall that will need replaced.
